# Alder Rise — SAMPLE / fictional development

## Morning walk · 21 September · whole audit

Report SITE-20260924-0900 · made 24 Sept 2026, 09:00 from the records on the site manager's device

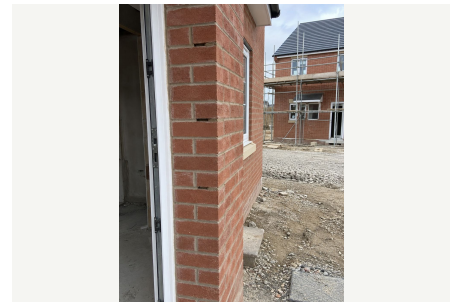
Primary evidence · #001

**Mortar joints left open at the entrance reveal beside the door frame. Complete the pointing and clean the facing brickwork.**

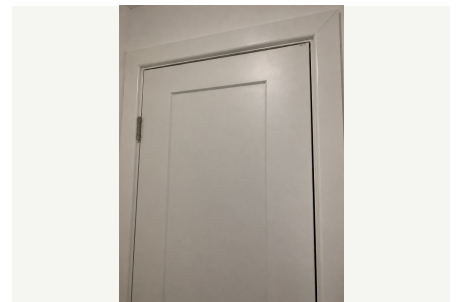
Primary evidence · #002

**Ground-floor cupboard door catches on the frame at the head. Adjust and recheck the full opening swing.**

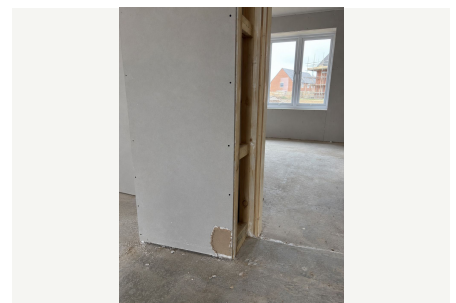
Primary evidence · #003

**Plasterboard face damaged at the base beside the hallway doorway. Make good the board before taping and finishing.**

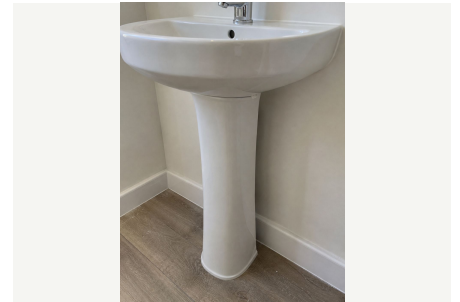
Primary evidence · #005

**Small chip to the upper front edge of the cloakroom basin pedestal, just below the basin. Replace the damaged pedestal and leave the basin properly supported.**

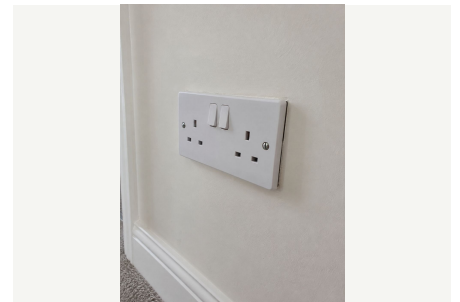
Primary evidence · #006

**Living-room socket faceplate not seated evenly against the wall. Check the back box and refix the faceplate.**

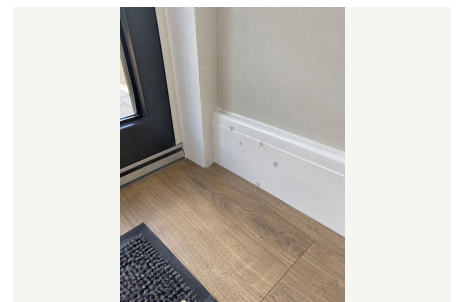
Primary evidence · #007

**Latex overspill on skirting. Remove the latex overspill from the hallway skirting and leave a clean finish.**

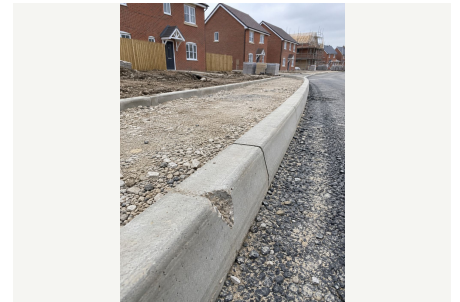
Primary evidence · #008

**Corner chipped on the new kerb opposite Plot 43. Make good or replace the damaged section before the final surfacing.**

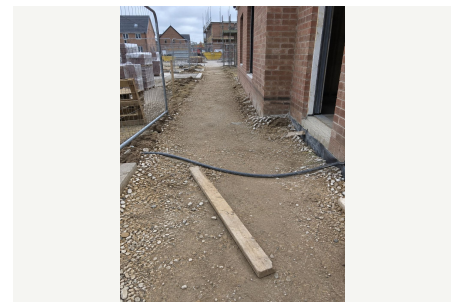
Primary evidence · #010

**Loose timber and conduit across the temporary pedestrian route beside Plot 42. Clear the obstruction and keep this route free from stored materials.**
