## Pre-completion check

**Plot 14, Oakfield Meadow, Thornbury, Bristol BS35 2QW**

**Fairhaven Homes**

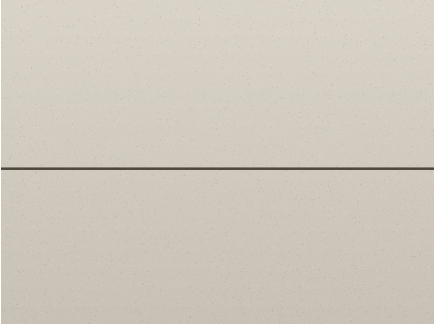
Photo 1 · 14 Sept 2026, 11:11

## Joint open, uneven or not flush

A joint in the worktop is open, uneven or not flush.

**Adjust or remake the joint so it is flush and tight.**

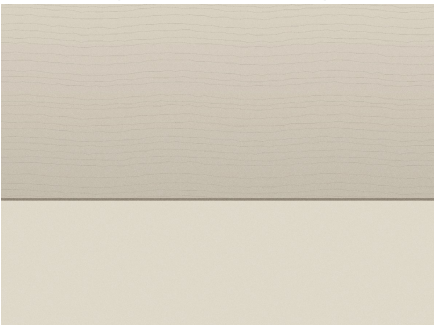
Photo 1 · 14 Sept 2026, 12:40

## Loose or coming away

A skirting board or door frame is loose or has come away from the wall.

**Refix the skirting board or door frame securely and make good the finish.**

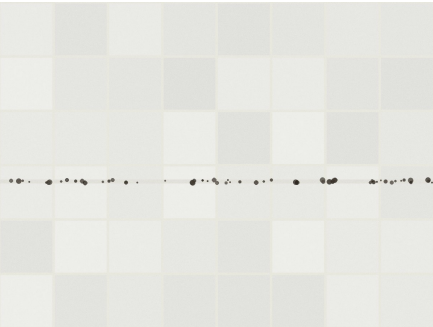
Photo 1 · 14 Sept 2026, 12:05

Sealant discoloured or mouldy

The sealant around the bath, shower or basin is discoloured or has mould-like marks.

Replace the sealant. If the problem returns, investigate ventilation and moisture.
